1. REPORT DATE		2. REPORT TYPE Viewgraphs		3. DATES COVERED	
4. TITLE AND SUBTITLE  Ultrasonic Imaging of TTCP Samples				5a. CONTRACT NUMBER	
				5b. GRANT NUMBER	
				5c. PROGRAM ELEMENT NUMBER

# *The Technical Cooperation Program (TTCP)*

#### *Evaluation of Samples Using Ultrasound Imaging*

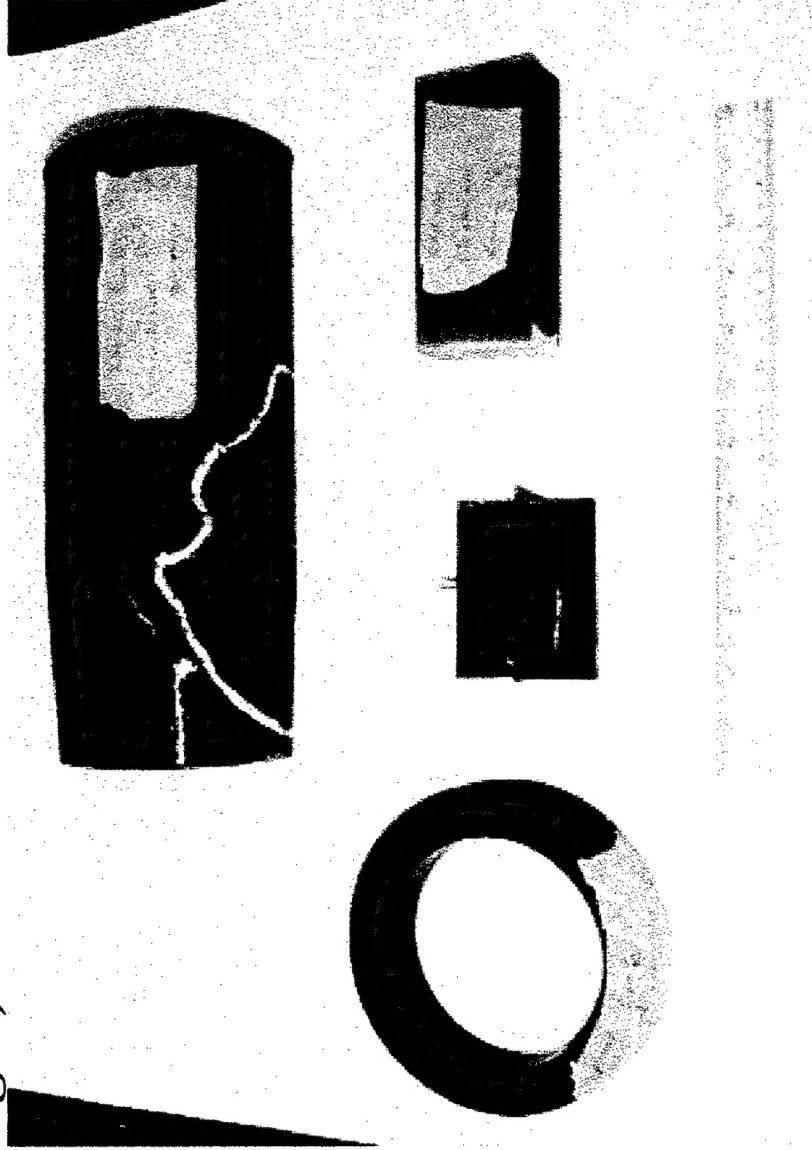
RAH66 Quill Detector Face Drive Shaft (top), Quill Shaft  
(bottom left), small brace (bottom center), and flex beam  
(bottom right)

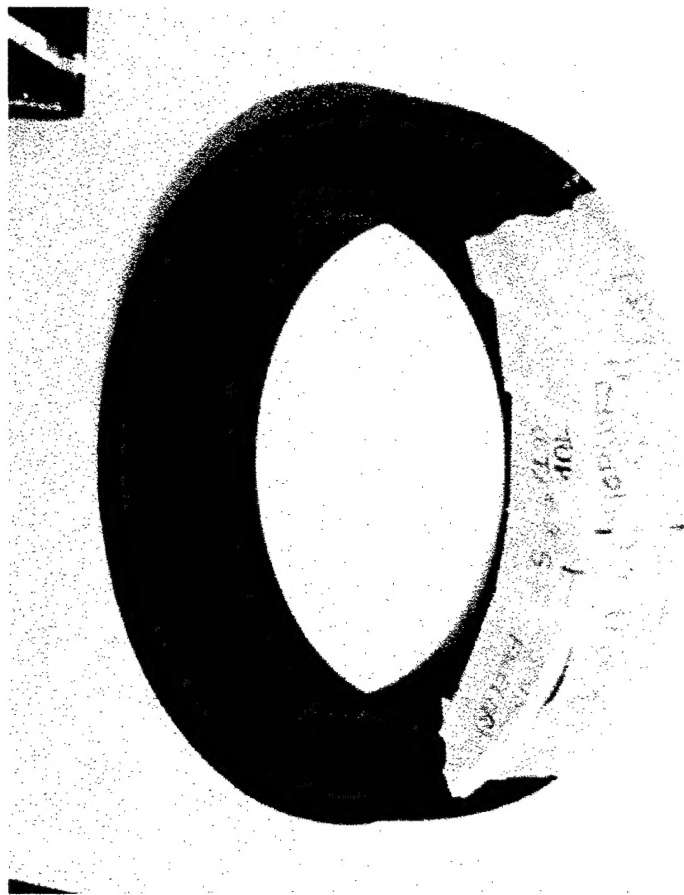
RAH 66 Quill Shaft 7/8" thick by 6" dia. By 1 1/8" high ring.

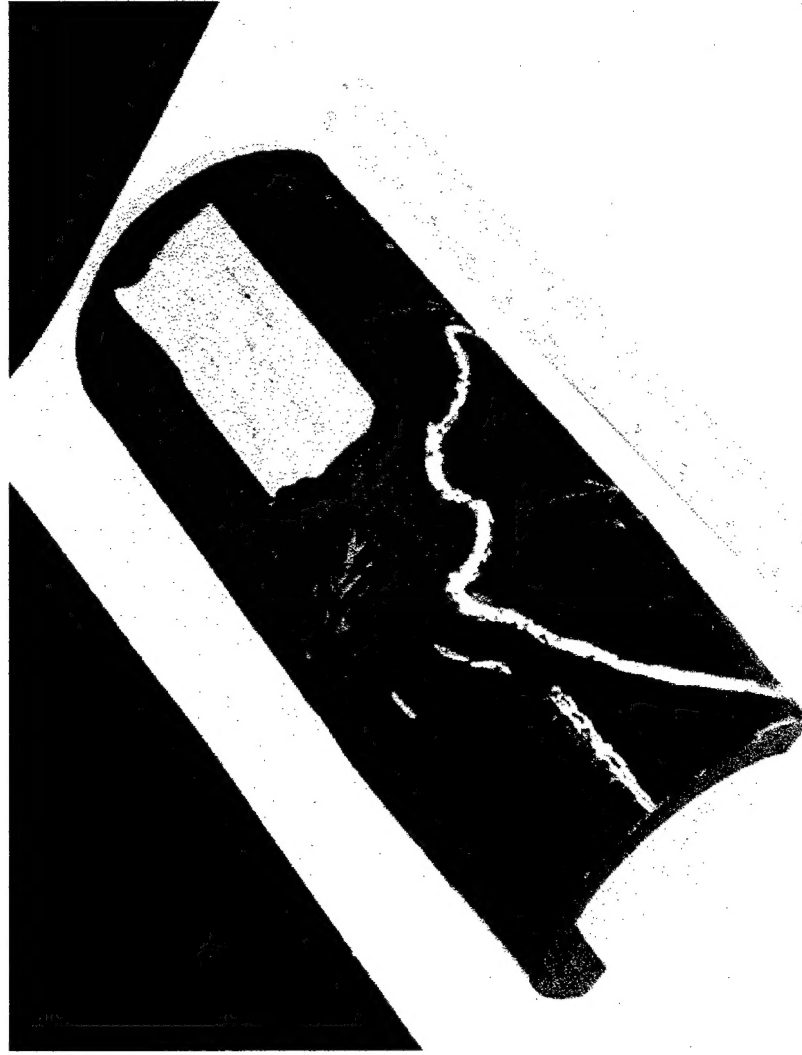
RAH66 Quill Detector Face (Dr) Shaft Examined by through transmission. Thickness is 1/2 inch to 1 inch. Height 12.5 inch, 5 3/4 inch diameter

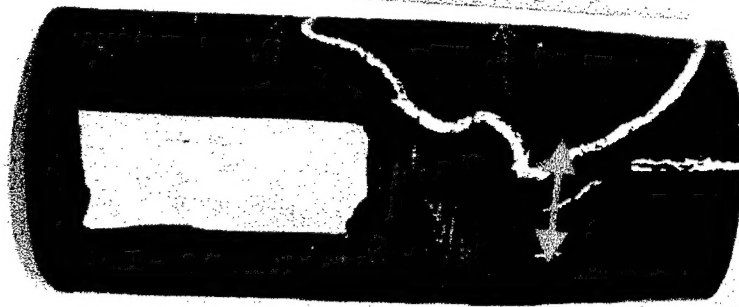
Quill Detector Face Bottom section –heavy thickness section  
examined by through transmission at 2.25 MHz

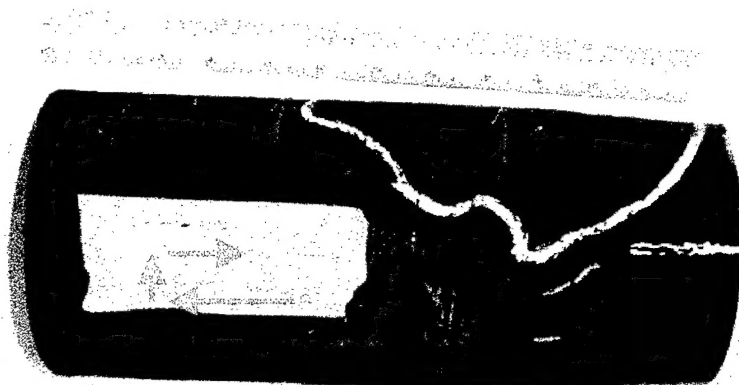
RAH66 Quill Detector Face (Dr) Shaft imaged using a 2.5 MHz  
1.5" diameter transducer in through transmission. The thin  
Top Section is approximately 0.625 inch thick.

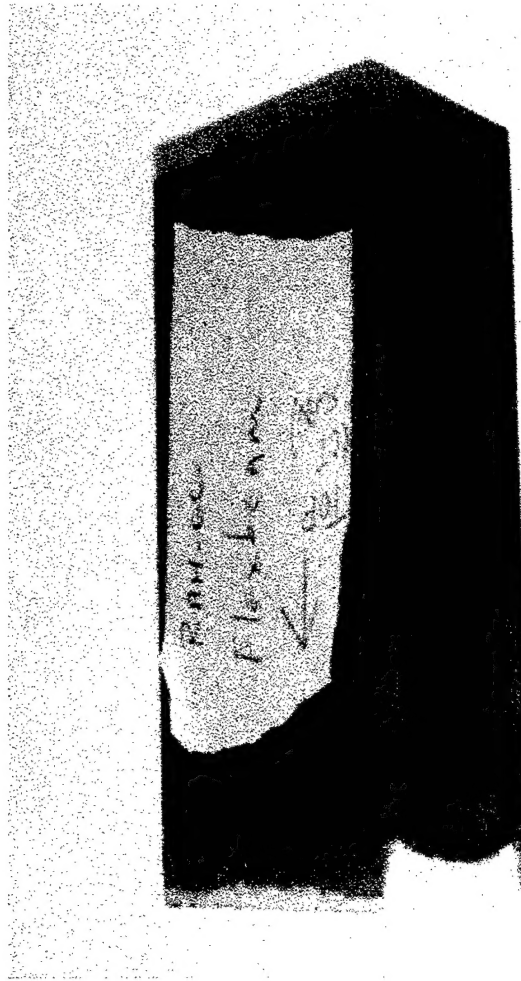
The RAH66 Flex beam, 1.125" thick x 5.25" x 2.375"

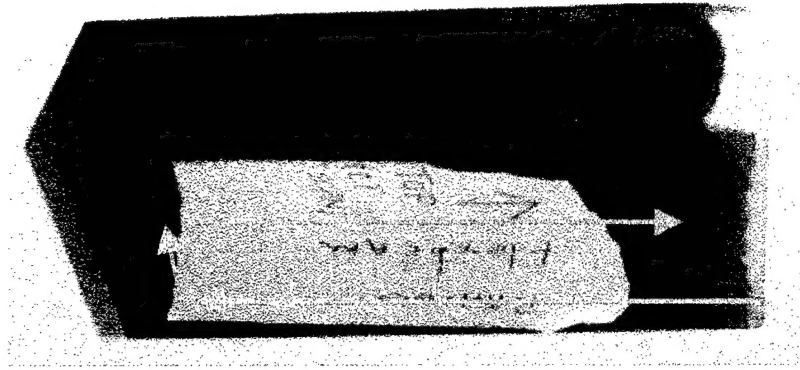
RAH66 Flexbeam imaged using Through Transmission at  
2.25 MHz shows a darker line of marceling near the top

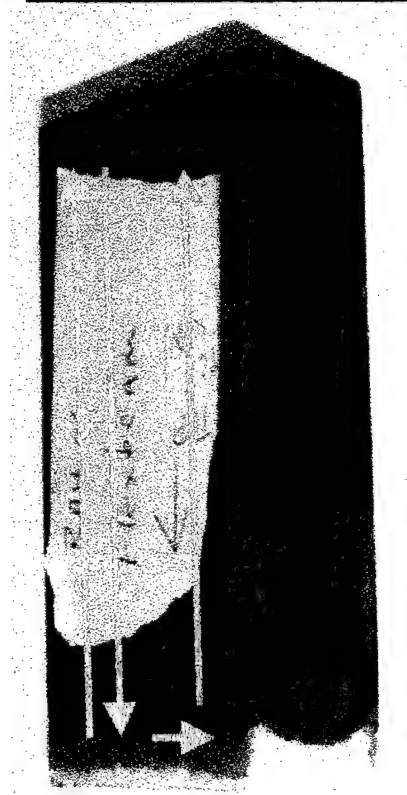
RAH66 Flex beam in tank. One sided imaging of the ultrasound by reflection shows some near surface discontinuities near the end of the flex beam.

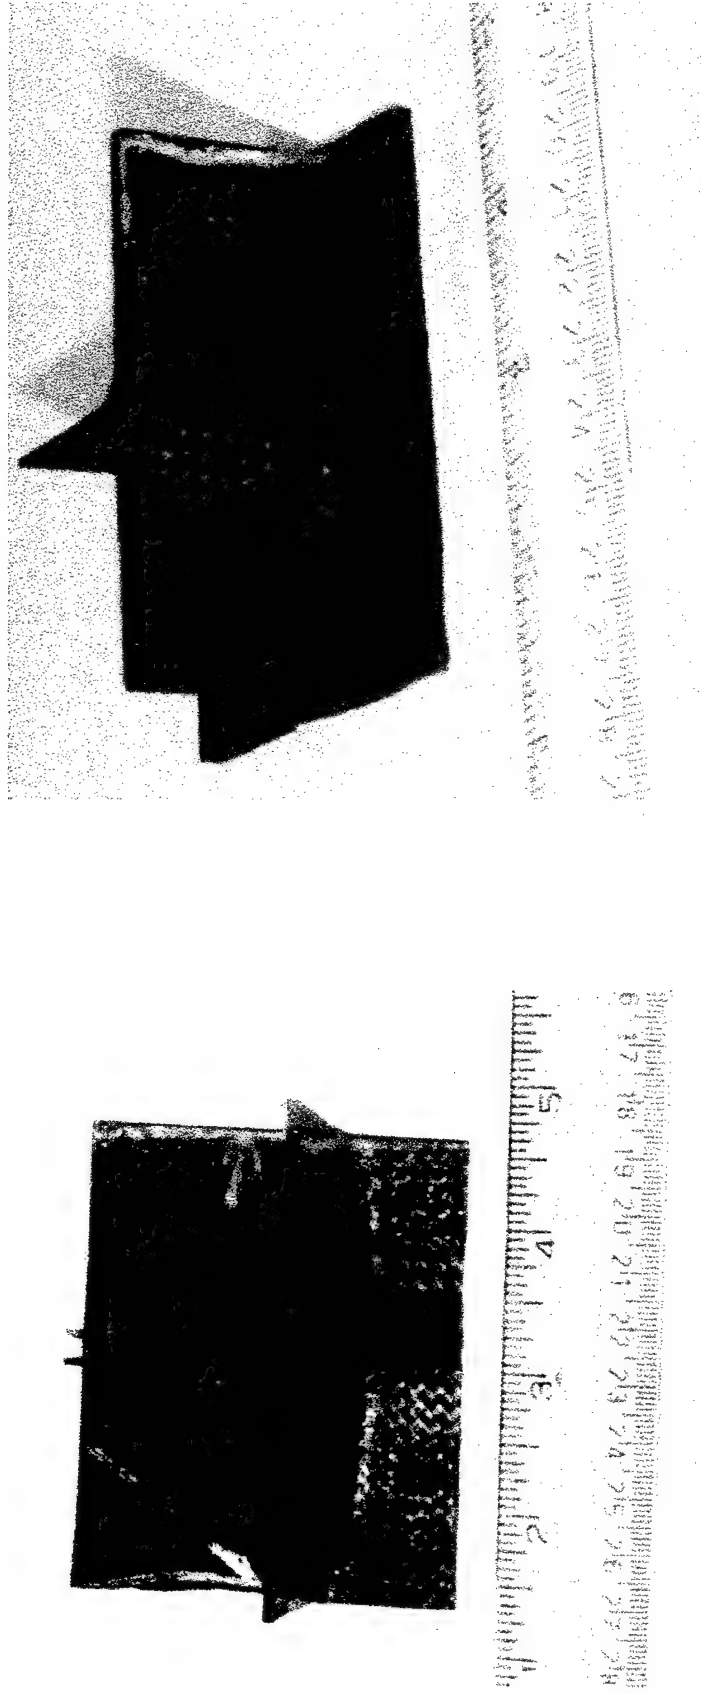
## IAMT prepreg box, overhead and side views

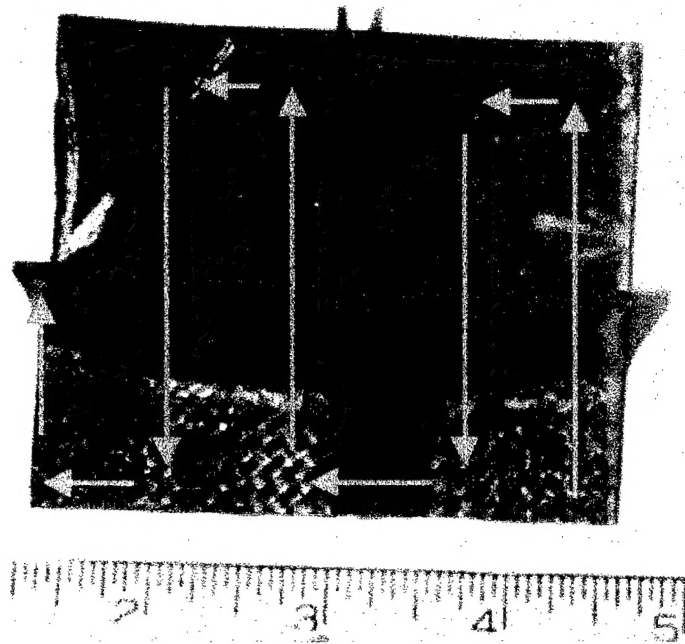
IAMT prepreg box imaged in through transmission  
using 5 MHz for high resolution

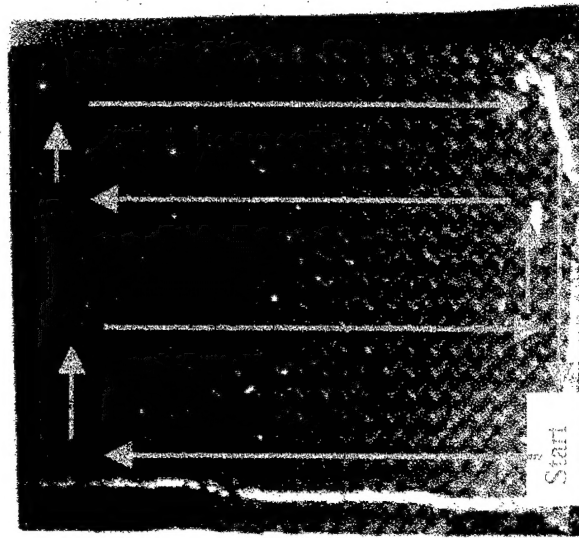
IAMT prepreg box imaged using the reflection camera in the tank. Back reflection imaging of the bottom of the part shows a discontinuity on one corner, and a surface discontinuity

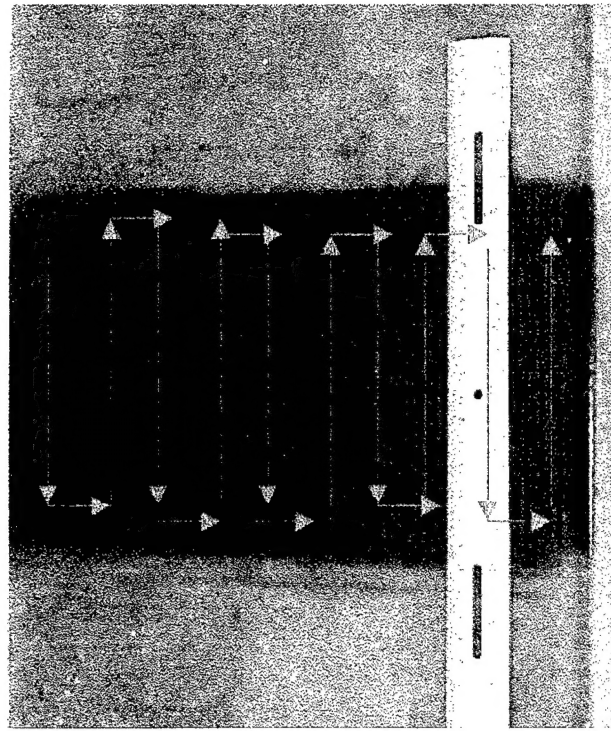
3 cm thick balsa wood cored multilayer panel imaged  
using 5 MHz ultrasonic reflection camera in reflection
